Midway City Council
20 September 2022
Regular Meeting

The Village /
Underground Garages

CITY COUNCIL MEETING STAFF REPORT

DATE OF MEETING: September 20, 2021
NAME OF PROJECT: The Village
NAME OF APPLICANT: Midway Heritage Development, LLC
AUTHORIZED REPRESENTATIVE: Daniel Luster
AGENDA ITEM: Below Grade Garages
LOCATION OF ITEM: 541 East Main Street
ZONING DESIGNATIONS: C-2

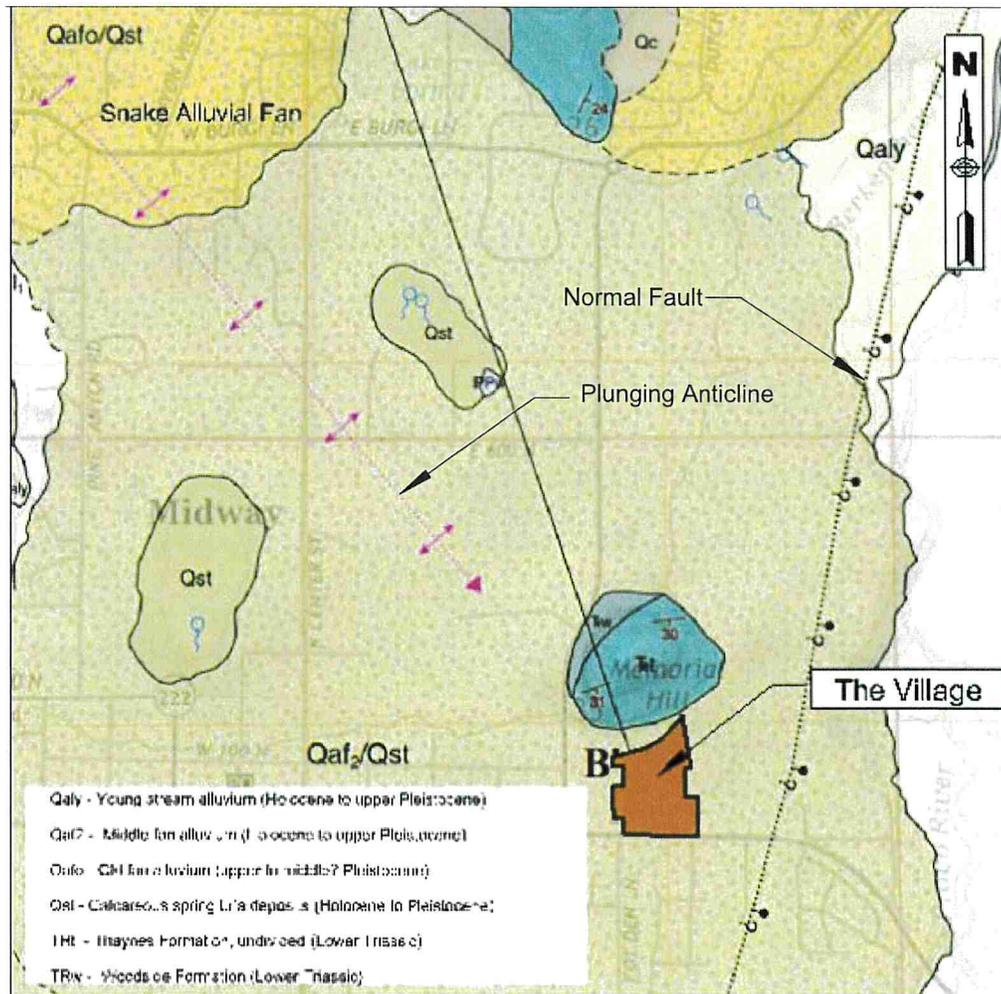
Horrocks Engineers
 The Village
 Geologic Map
 Figure 3

Reference: Biek, 2019

0 1/8 1/4
 APPROXIMATE SCALE IN MILES

Midway is in the western part of Heber Valley. Figure 3 is modified from Biek (2019) to show the surficial geology of The Village and Midway areas. Unconsolidated deposits near The Village include eastward-sloping alluvial fans of Quaternary-age unconsolidated sediments that include poorly to moderately sorted, weakly to non-stratified, clay-to boulder-sized sediment shed from the Wasatch Mountains. These sediments were deposited principally by debris flows and debris floods at the mouths of active drainages such as Snake Creek and form alluvial fans (Biek, 2019). Well logs indicate the unconsolidated valley-fill deposits primarily consist of lenticular and discontinuous beds of poorly sorted material ranging in size from clay to boulders. In Midway, these unconsolidated deposits are interlayered with tufa (hot spring) deposits.

Figure 3 shows that the inferred anticline plunges (dives) to the southeast, towards, but ends north of Memorial Hill before reaching The Village. The tufa deposits are locally more than 100 feet thick and are underlain by alluvium (Kohler, 1979). The thickness of unconsolidated deposits overlying bedrock is confirmed in some of the well logs in Attachment 1. Tufa deposits crop out or interfinger with unconsolidated valley-fill deposits at shallow depths in the vicinity of Midway (Roark and others, 1991).

Figure 3 – Geologic Map

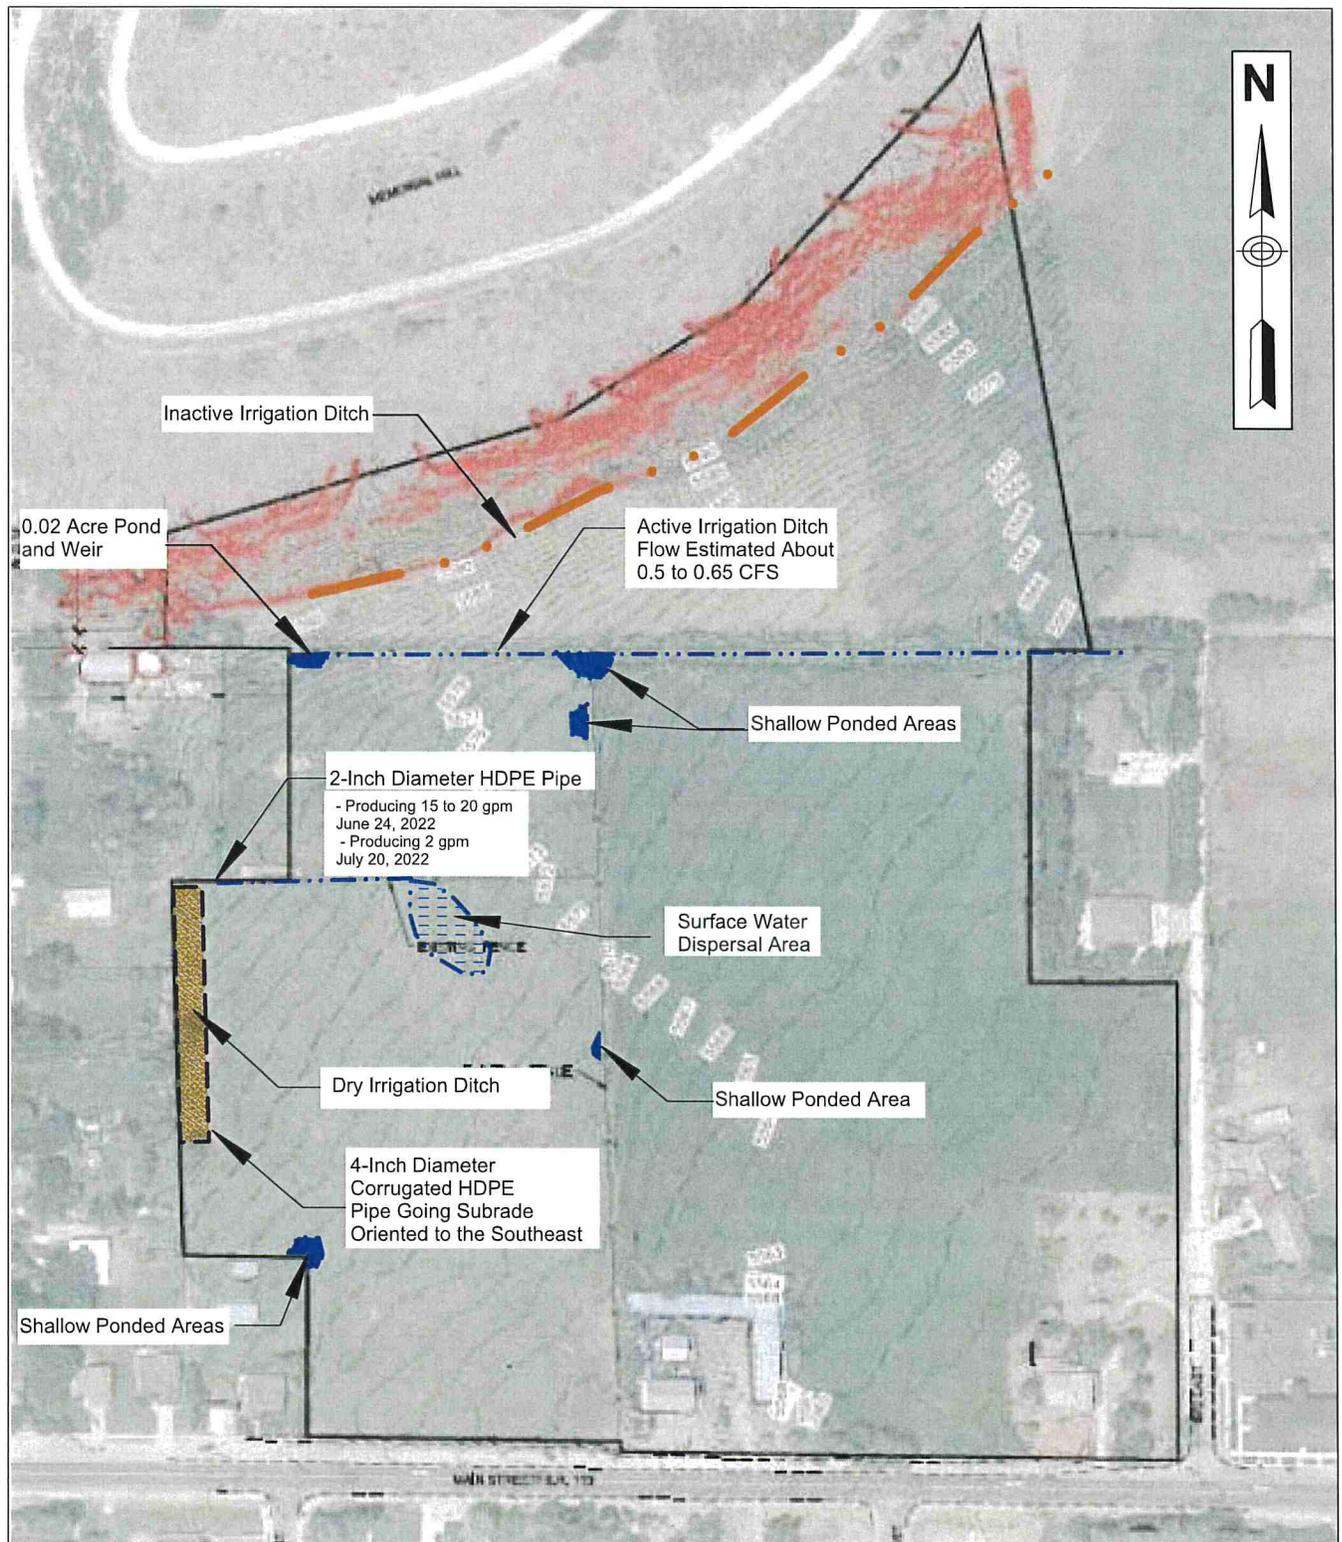
Reference: Berg Engineering - Sensitive Lands Map, Sheet 2, May 25, 2022

Loughlin Water observations on June 24 and July 20, 2022
